LAKE • GEORGE
WATERKEEPER®

July 24, 2008

Re: Lake George Association – Dredging of Foster Brook
Application No. 5-5324-00073/00001

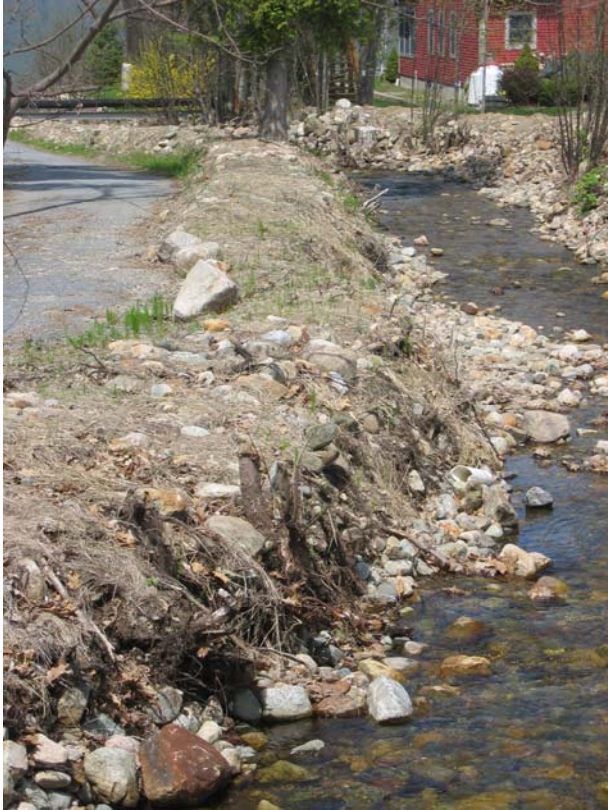
PHOTOGRAPH 1

Foster Brook section indicating the installation of a berm to channelize the stream. Erosion is evident along the lower portions of the bank at the stream elevation.

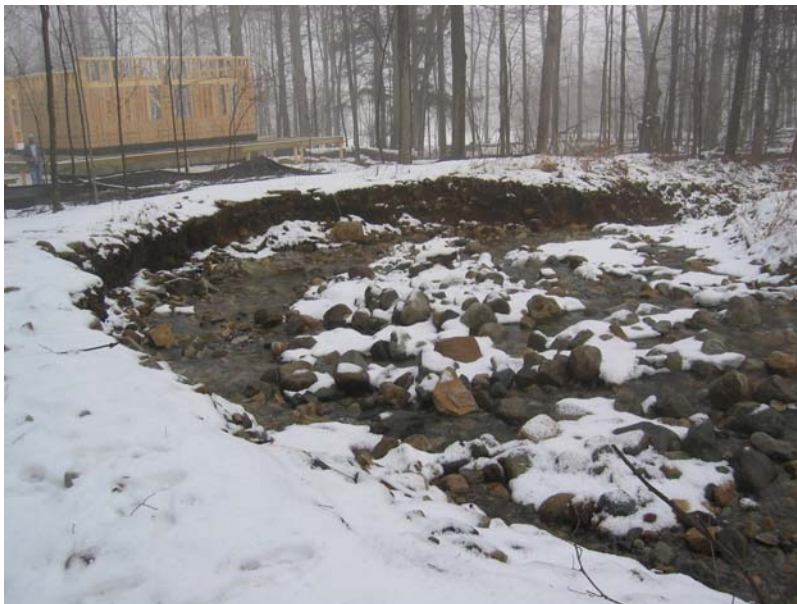
PHOTOGRAPH 2

2. In lieu of proactive measures to reduce excess stormwater and sedimentation from entering the stream, an in-stream sediment basin has been installed in Foster Brook. In January 2006, a significant failure in the basin resulted in massive scouring and downstream flooding. This was a result of the extreme "flashy" nature of the stream that experiences substantial flow fluctuations as well as design flaws. Please refer to Photographs 2 and 3. The basin was reconstructed in the same location with more riprap used as stabilization. The Stream Assessment Project of the Lake George Waterkeeper has been monitoring these in-stream devices throughout the watershed and has found these devices may not reduce the amount of sediment entering the lake. Please refer to Photograph 4 which shows the bottom of the in-stream basin one year after reconstruction. Sediment does not appear to be accumulating in these devices. Is there any record of cleanouts of the basin

Photograph taken on January 30, 2006 depicting a washout of the recently constructed in-stream sediment basin. This basin was located on a bend in the stream.

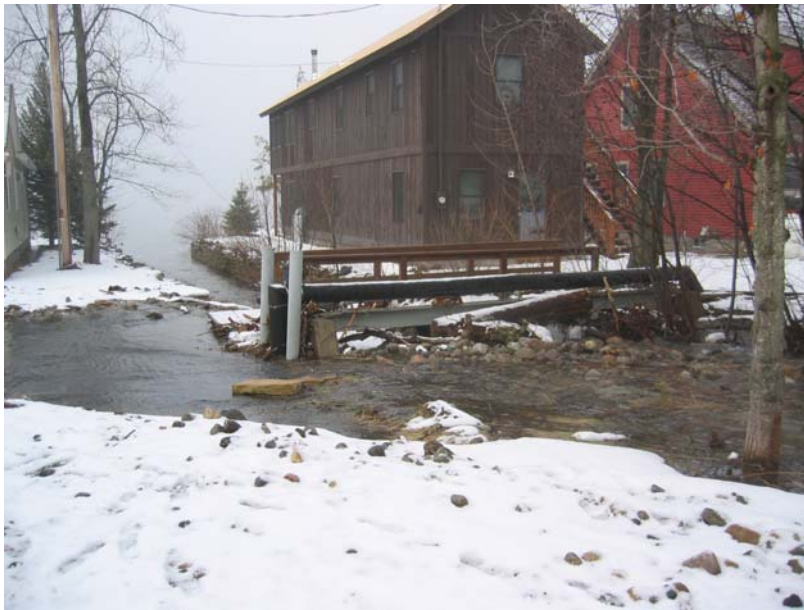
PHOTOGRAPH 3

Photograph taken on January 30, 2006 depicting the lower portion of Foster Brook. Notice the area where the stream left its banks. This was a result of channelization, restriction from the bridge and above grade sewer pipe and material washed out from the basin.

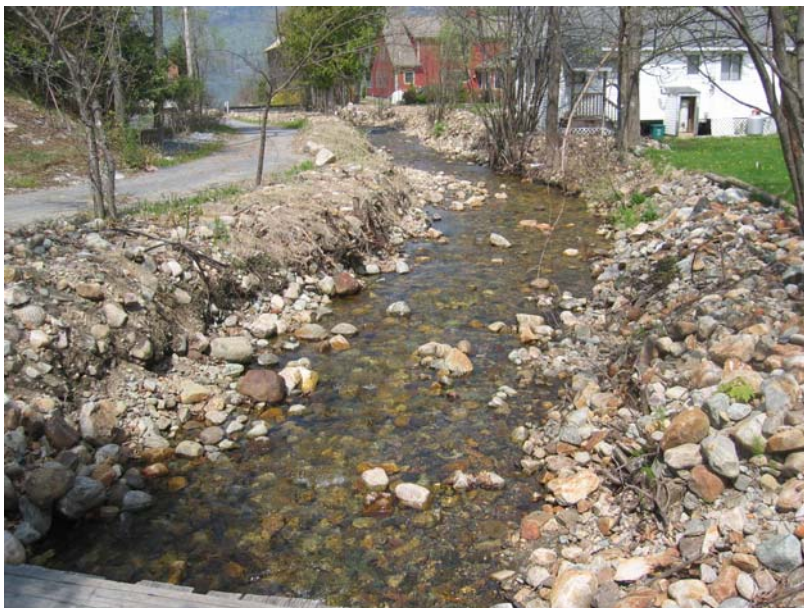
PHOTOGRAPH 4

3. There has been no consideration of the preservation of a riparian buffer along the stream corridor, the most effective control measure for sediment removal. Please refer to Photograph 4, which depicts a complete removal of vegetative buffer along the stream corridor. The requirement of a buffer should be part of any sediment management program.

Cross-section of Foster Brook detailing a complete lack of riparian buffer. Along the stream bank there is evidence of trees stumps.

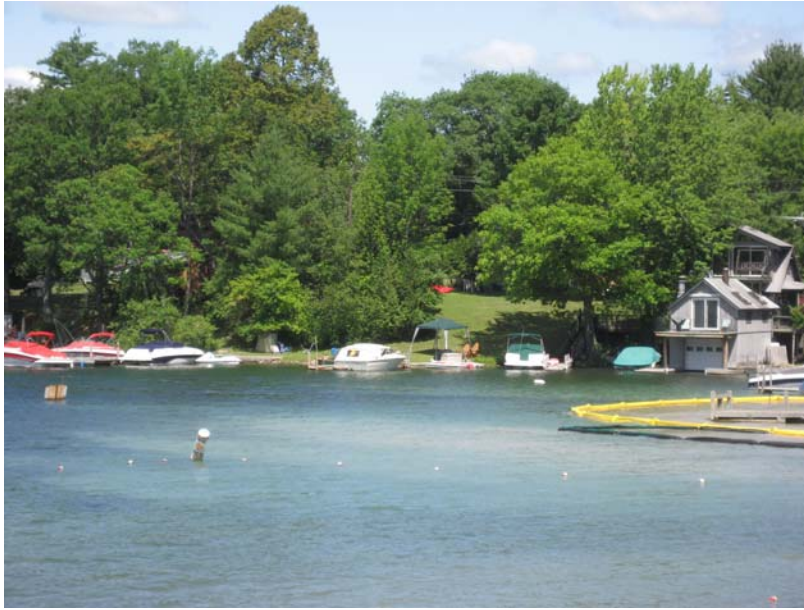
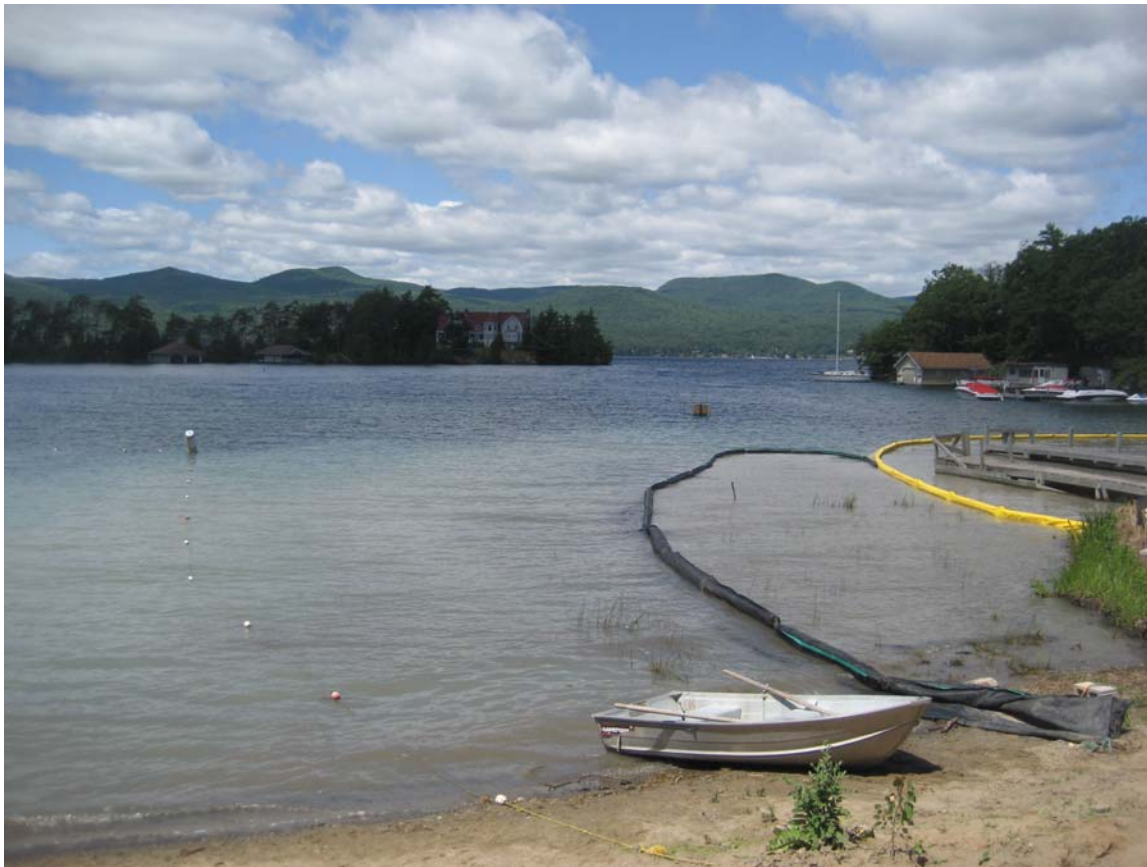
PHOTOGRAPH 5 & 6

- There were significant levels of turbidity outside the curtain as evident in Photographs 5 and 6. Due to this situation, it was determined an additional turbidity curtain was required. A curtain was not readily available and it one week to install the additional measure. However the dredging operations did not cease. This was contrary to Natural Resource Permit Condition 13 which states "If during dredging operations turbidity is produced outside of the containment area that causes substantial, visible contrast to the natural condition or results in a deposition of settleable solids, the permittee shall immediately cease work ...". This level of enforcement is unacceptable and the enforcement of permit conditions needs to be improved to protect water quality.

Dredging operations at Gull Bay. Photographs taken on July 10, 2006 indicating elevated turbidity outside the curtain. It was determined on prior days that an additional curtain would be required to reduce the turbidity levels. However, operations continued in disregard of permit conditions.
